Report of: Robin Mewes BSc (Hons) MRICS MEWI
 Specialist Field: Residential Surveyor & Valuer
 On: 32 Frederick Street
 On behalf of: Mr Happy

PRE-INSPECTION NOTES

1. INTRODUCTION

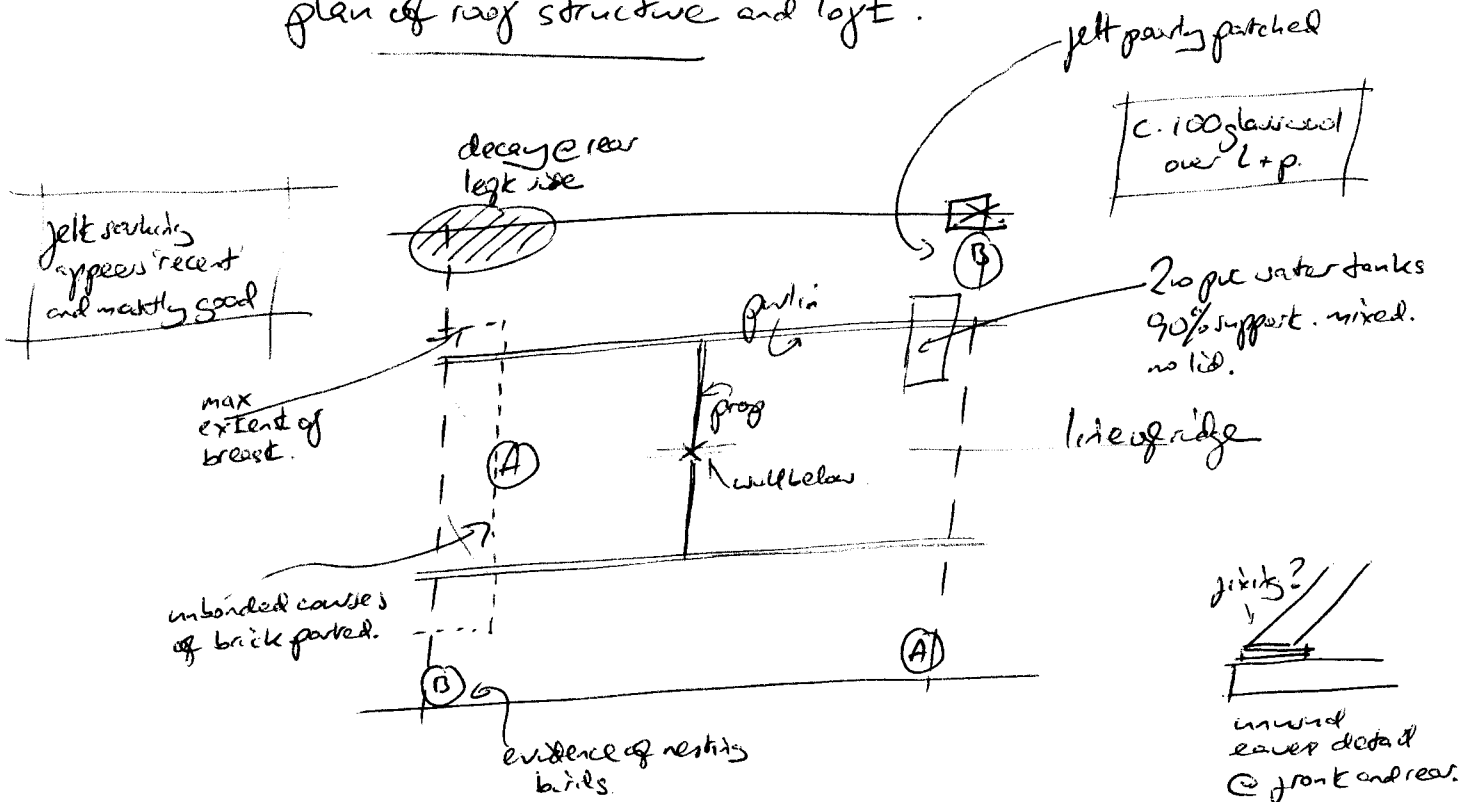
plan of roof structure and loyft.

(A) - Damp brickwork below parapet and/or dry streaks (B) - Patched rafters

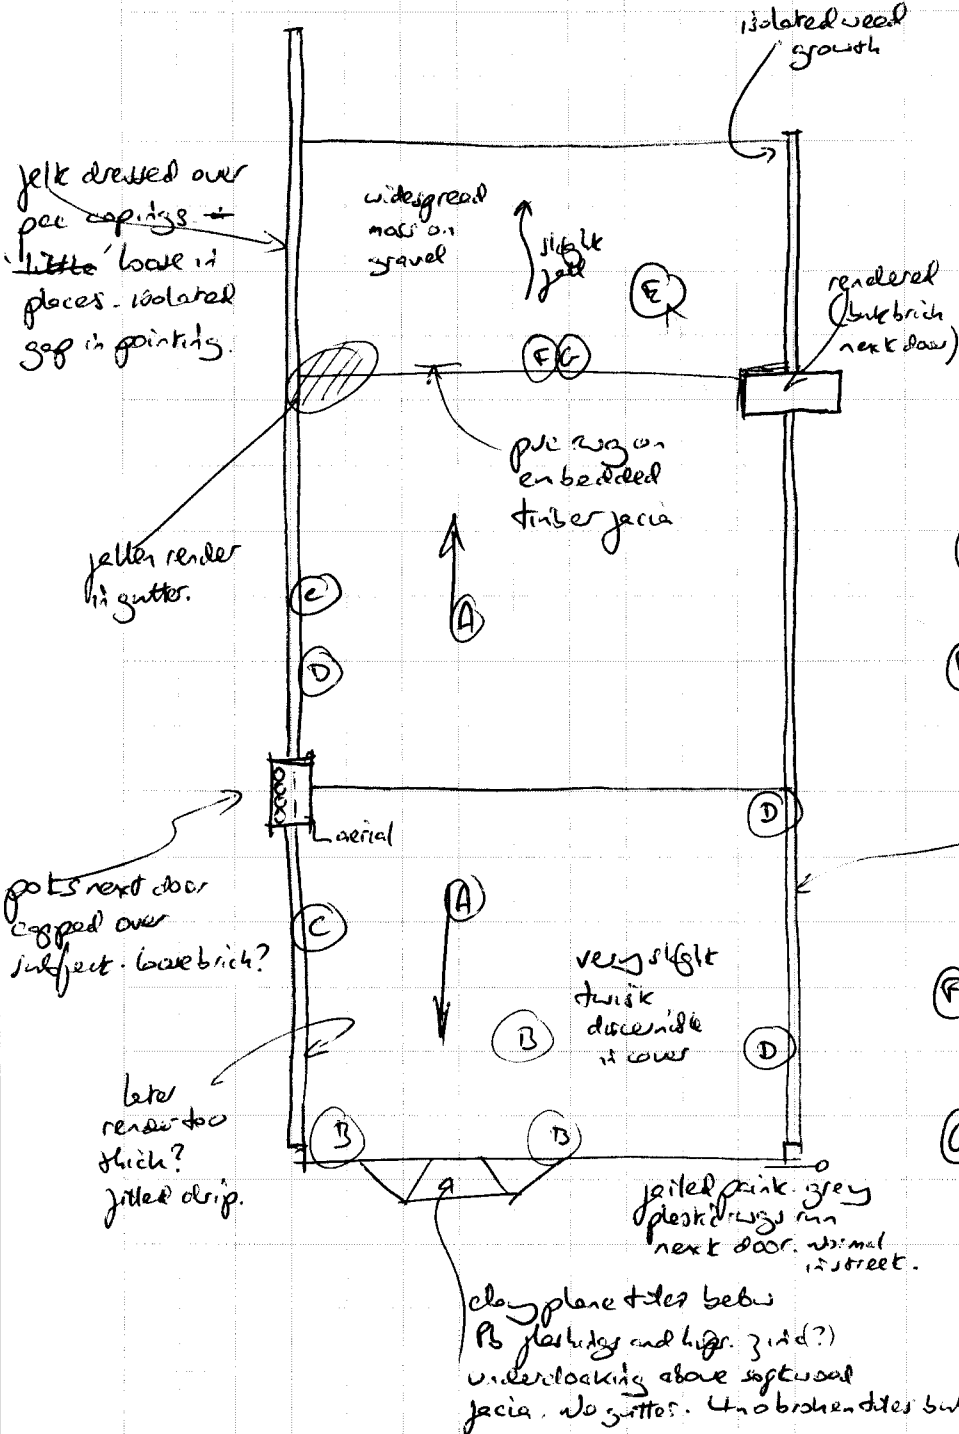
Roof
Floor Plan - NOT TO SCALE

- (A) Clay double roman tiles below clay ridge tiles.
- (B) Tiles out of line, lifted or otherwise need adjustment. (approx 3-6).
- (C) Cracked render - worse areas - eg's.
- (D) Flashing missing, slipped or lifted - eg's
- (E) jelt jelt roof. good chippings. no defects seen. E mazi - green > 10 yrs?

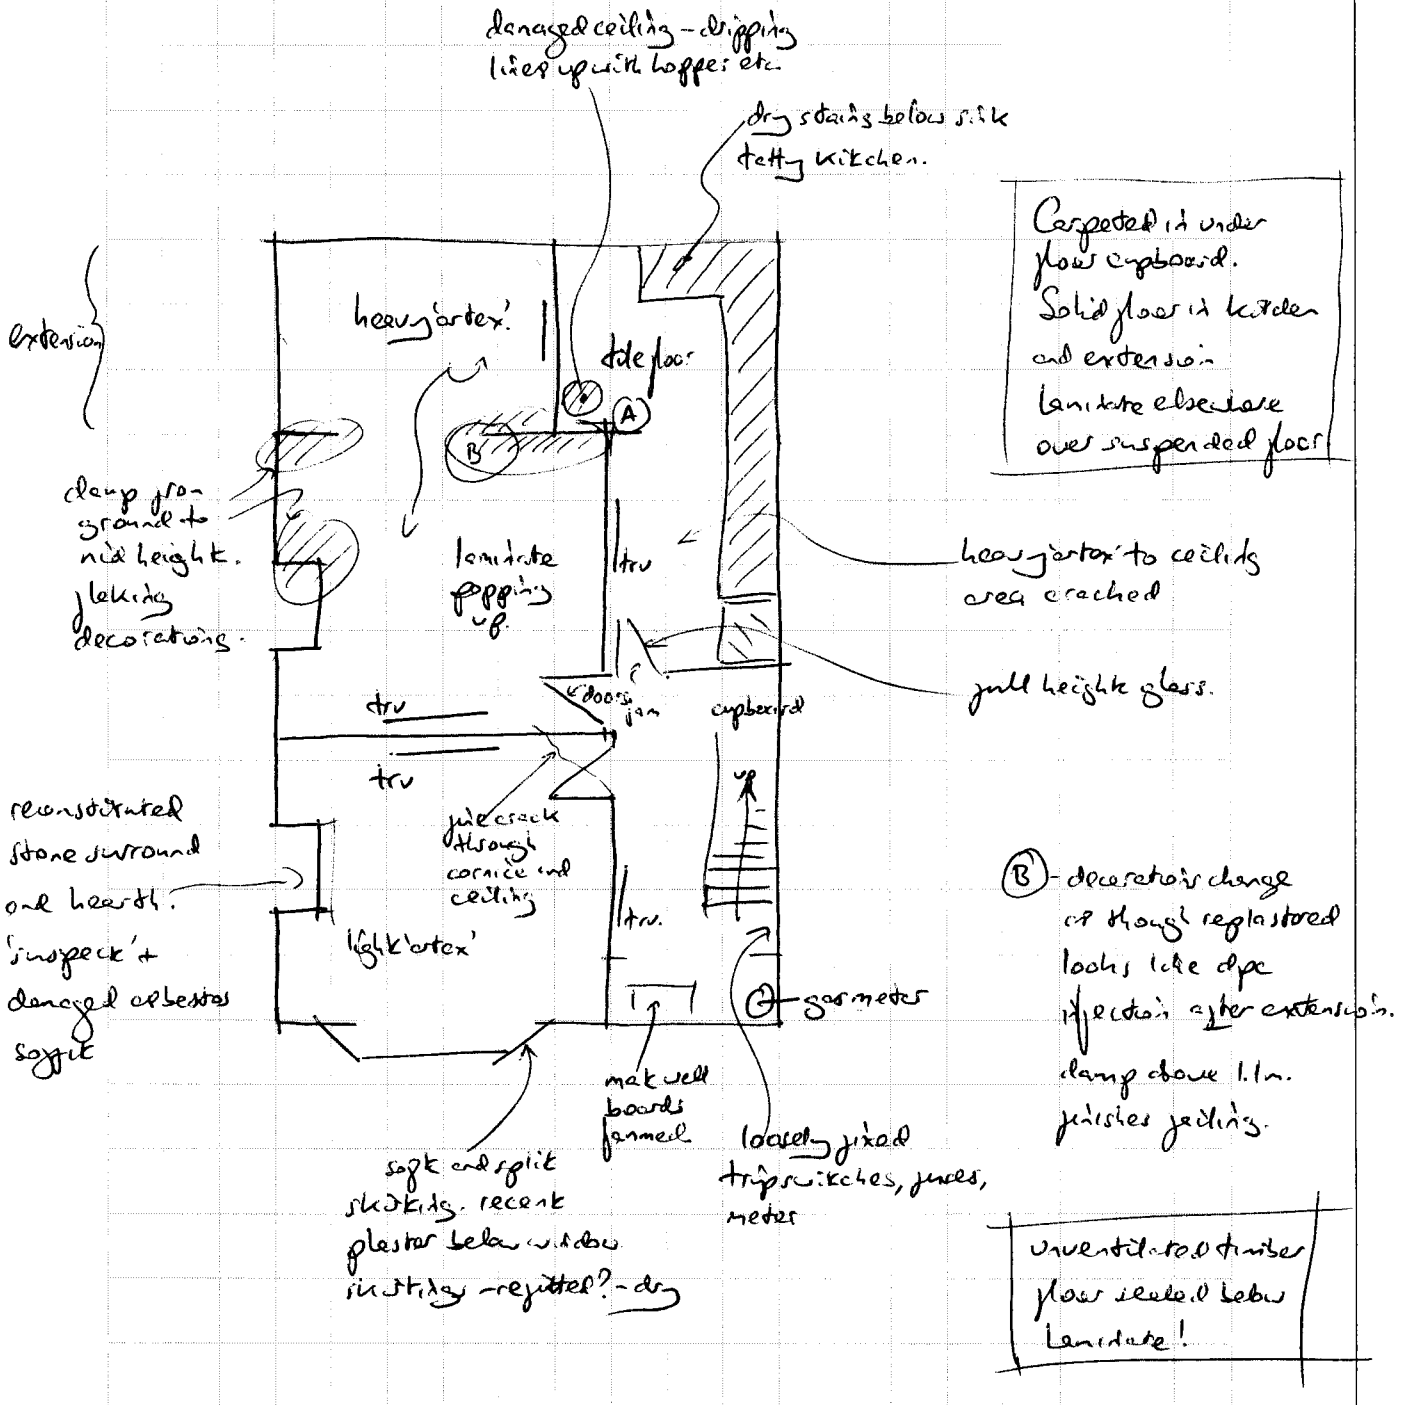
Ground Floor Plan - NOT TO SCALE

(A) - drylined corner - duct?
