THE RICS
HOMEBUYER
SURVEY & VALUATION

Property: 32 Frederick Street
Bristol
BS4 3PP

Inspected on: 19th December 2005

Inspected by: Allied Surveyors PLC
1 Pembroke Road
Clifton
Bristol BS8 3AU

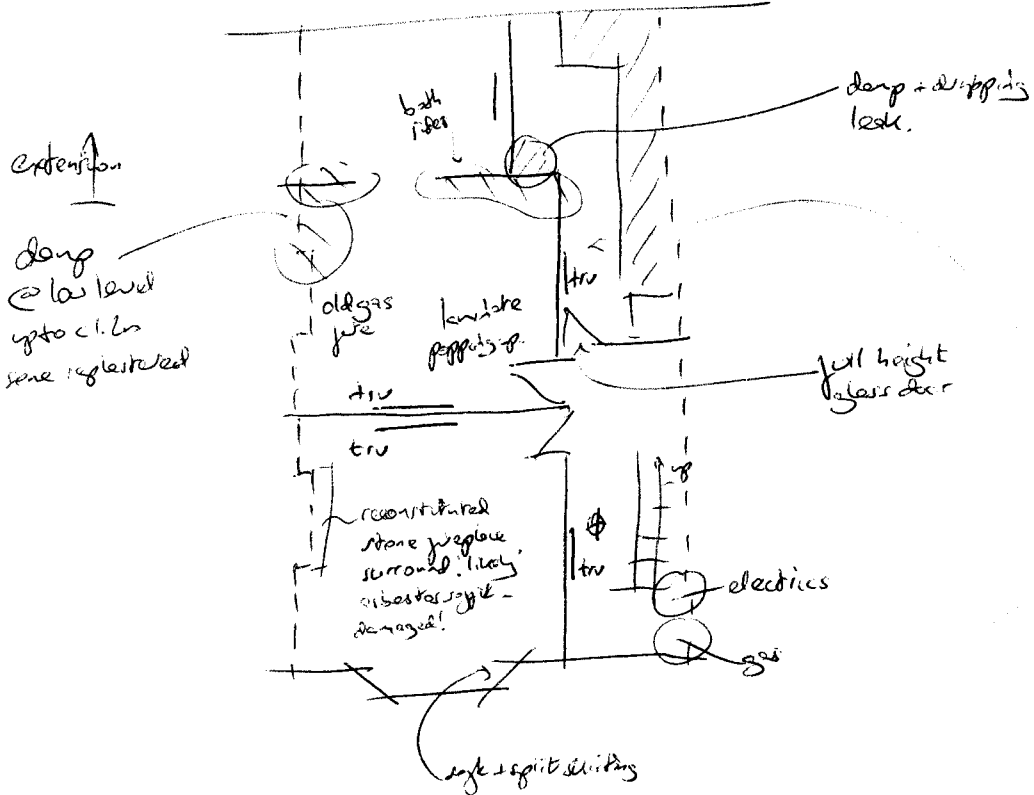
ground floor
 carpeted under the
 cupboard
 side floor is kitchen
 and extension
 laminate floor over
 work

TRV = thermostatic radiator valves
 L.P. = bath and plaster
 ⊕ = smoke detector
 damp stain and loose paper
