HCR - Property Risk Assessment

Site Notes – HCR

32 Frederick Street, Bristol

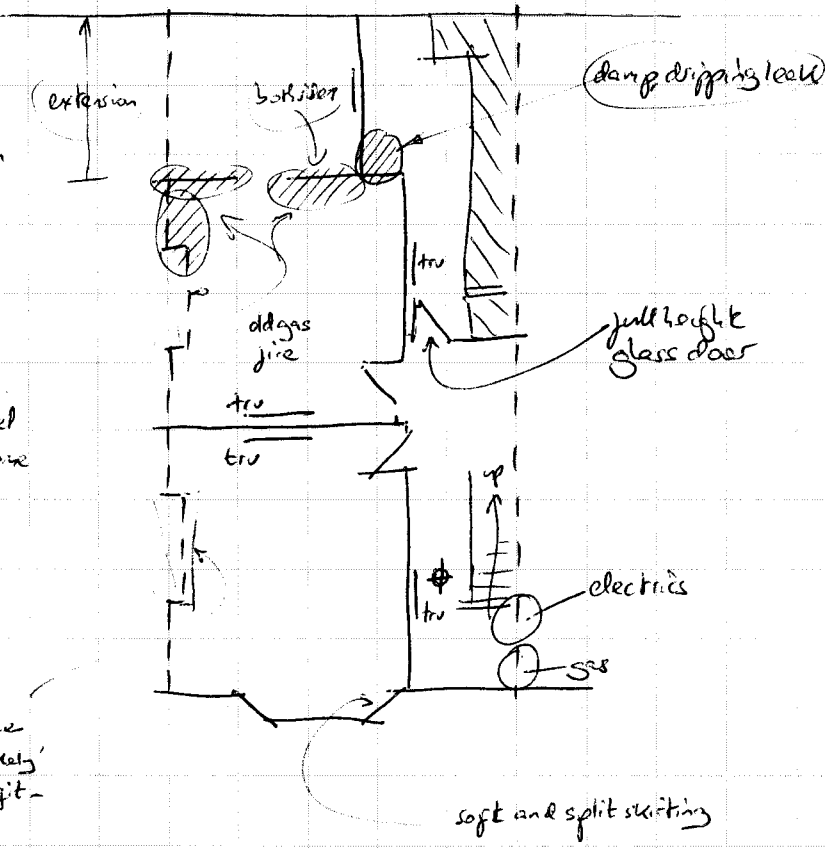
damp on low level up to c. 1.2m. Some replastered.

reconstituted stone fireplace surround. 'likely' asbestos soffit - damaged!

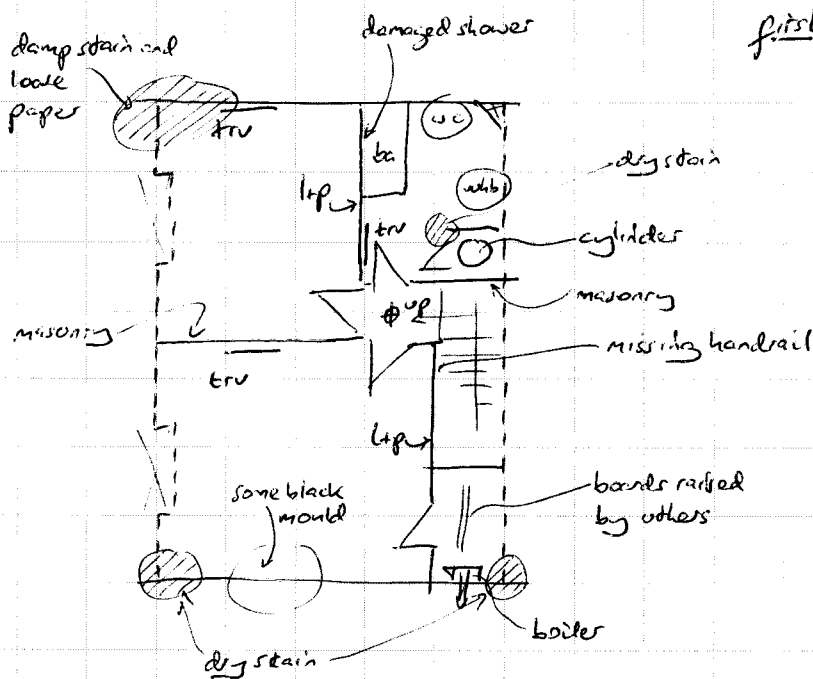
first floor: lath ceilings carpeted, except vinyl in bathroom

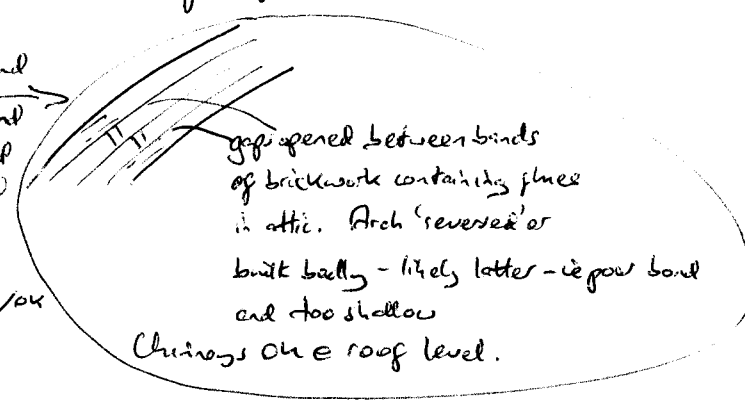
Movement	Linked sections
Walls / cracks/ plumbness /bulges	<p>Movement (describe and draw sketch or refer to photographs)</p> <p>normal - minor - eg lounge</p> <p>normal minor bow in front garden, 'weak' but effective</p>

<p>gaps opened between bricks of brickwork containing flues in attic. Arch 'reversed' or built badly - likely latter - ie poor bond and too shallow</p> <p>Chimneys on e roof level.</p>	E1
Floors / level / cracks		
Ceilings / cracks/bulges		
Window openings / cracks/ displacement		
Door openings/ cracks/ displacement		
Roof /level		
Architraves/gaps		
Skirtings /gaps		
Underpinning		
Chimneys		
Heave		
Lintols		
Cills		
Outbuildings/boundaries		
DPC	<p>E9 Dampness (describe, note position on floor plan sketch differentiate condensation)</p> <p>? may be set @ low level. suspect some infection in re-plastered parts</p> <p>Trace of putty repair external</p> <p>✓ = found X = none found</p>	D2, D3 D4 E1, E2, E3
